Safety News

Blue Ember Grills: Ask all Blue Ember grill owners to ensure proper assembly of burner hoses.

IMPROPER ASSEMBLY.

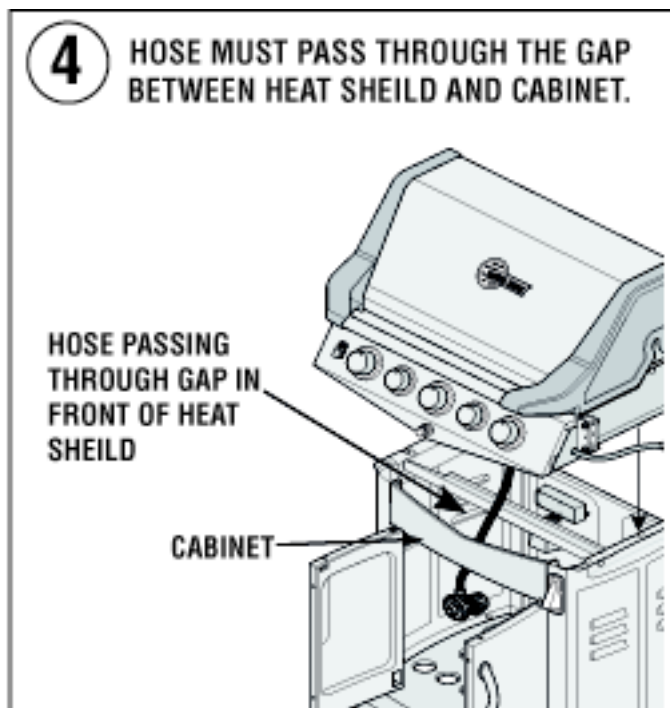
FIGURE 4

CORRECT HOSE ASSEMBLY

1. THE CUSTOMER NEEDS TO ENSURE THAT THE HOSE IS UNTIED FROM BURNER BEFORE FINAL ASSEMBLY (FIG 2)
2. CUSTOMER SHOULD RELEASE THE TIE AND PASS THE HOSE THROUGH THE GAP BETWEEN HEAT SHIELD AND FRONT PANEL BEFORE ASSEMBLING THE FIREBOX (BASE) TO THE CABINET (FIG. 3)
3. NATURAL GAS HOSE MUST PASS THROUGH THE GAP AND BE DIRECTED TO BOTTOM OF CABINET. PROPANE HOSE/REGULATOR MUST ALSO PASS THROUGH THE GAP TO THE CYLINDER UNDERNEATH THE HEAT SHIELD. (FIG 4)
4. **WARNING! HOSE MUST NOT TOUCH ANY PART OF THE FIRE BOX**
